PBY Catalina

Walk Around Number 5
squadron/signal publications

By William Scarborough
Color by Don Greer
Illustrated by Joe Sewell

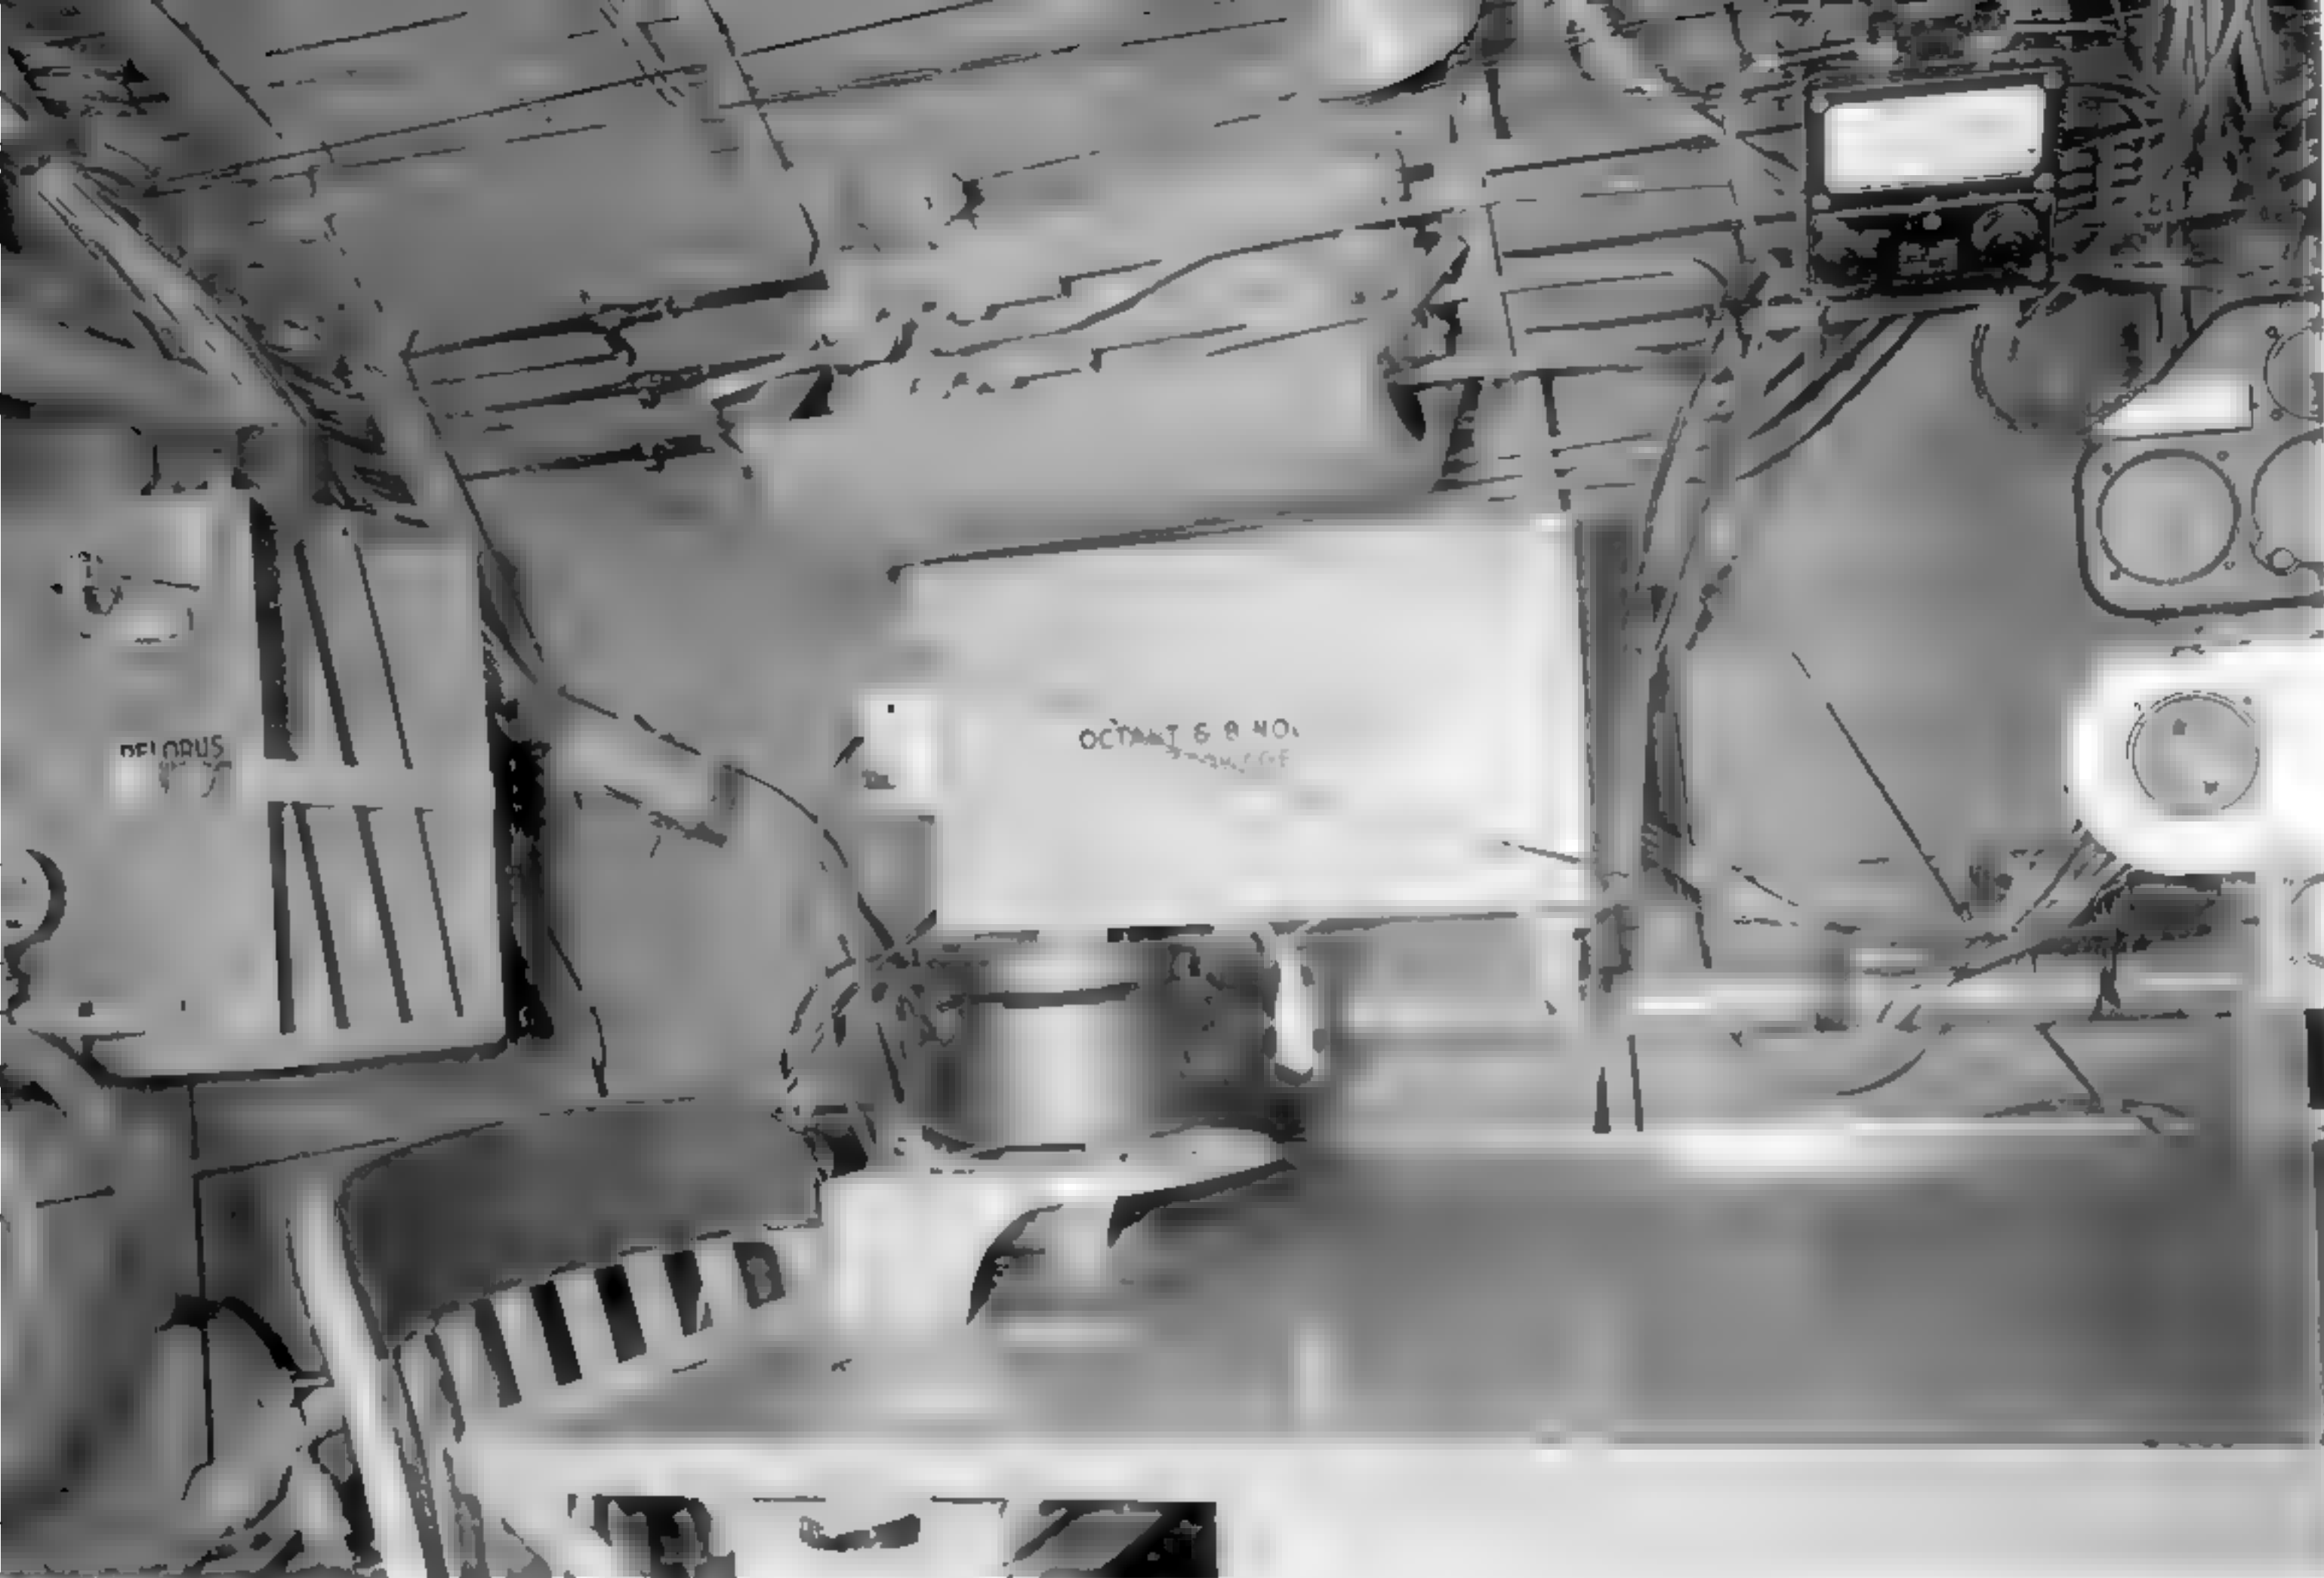
The opposite side of Navigator/Radio compartment. From left, forward: box for Navigation books with mount for Pelorus on side, Navigator's chair, Navigation table with drawer for chronometers (two were visible through the round windows in table), stowage for Octant and Binoculars. Compass was located on table at aft end. The meter at top and additional instruments above table are test equipment, standard Navigation instruments are above test equipment and include Temperature Gage (top) Airspeed, and Altimeter. The large drawer is for chart stowage. The semi-circular tray above Octant Stowage is a drip pan under hydraulic actuators for the auto pilot. The cone at top is the Navigator's Flood Light. (USN)

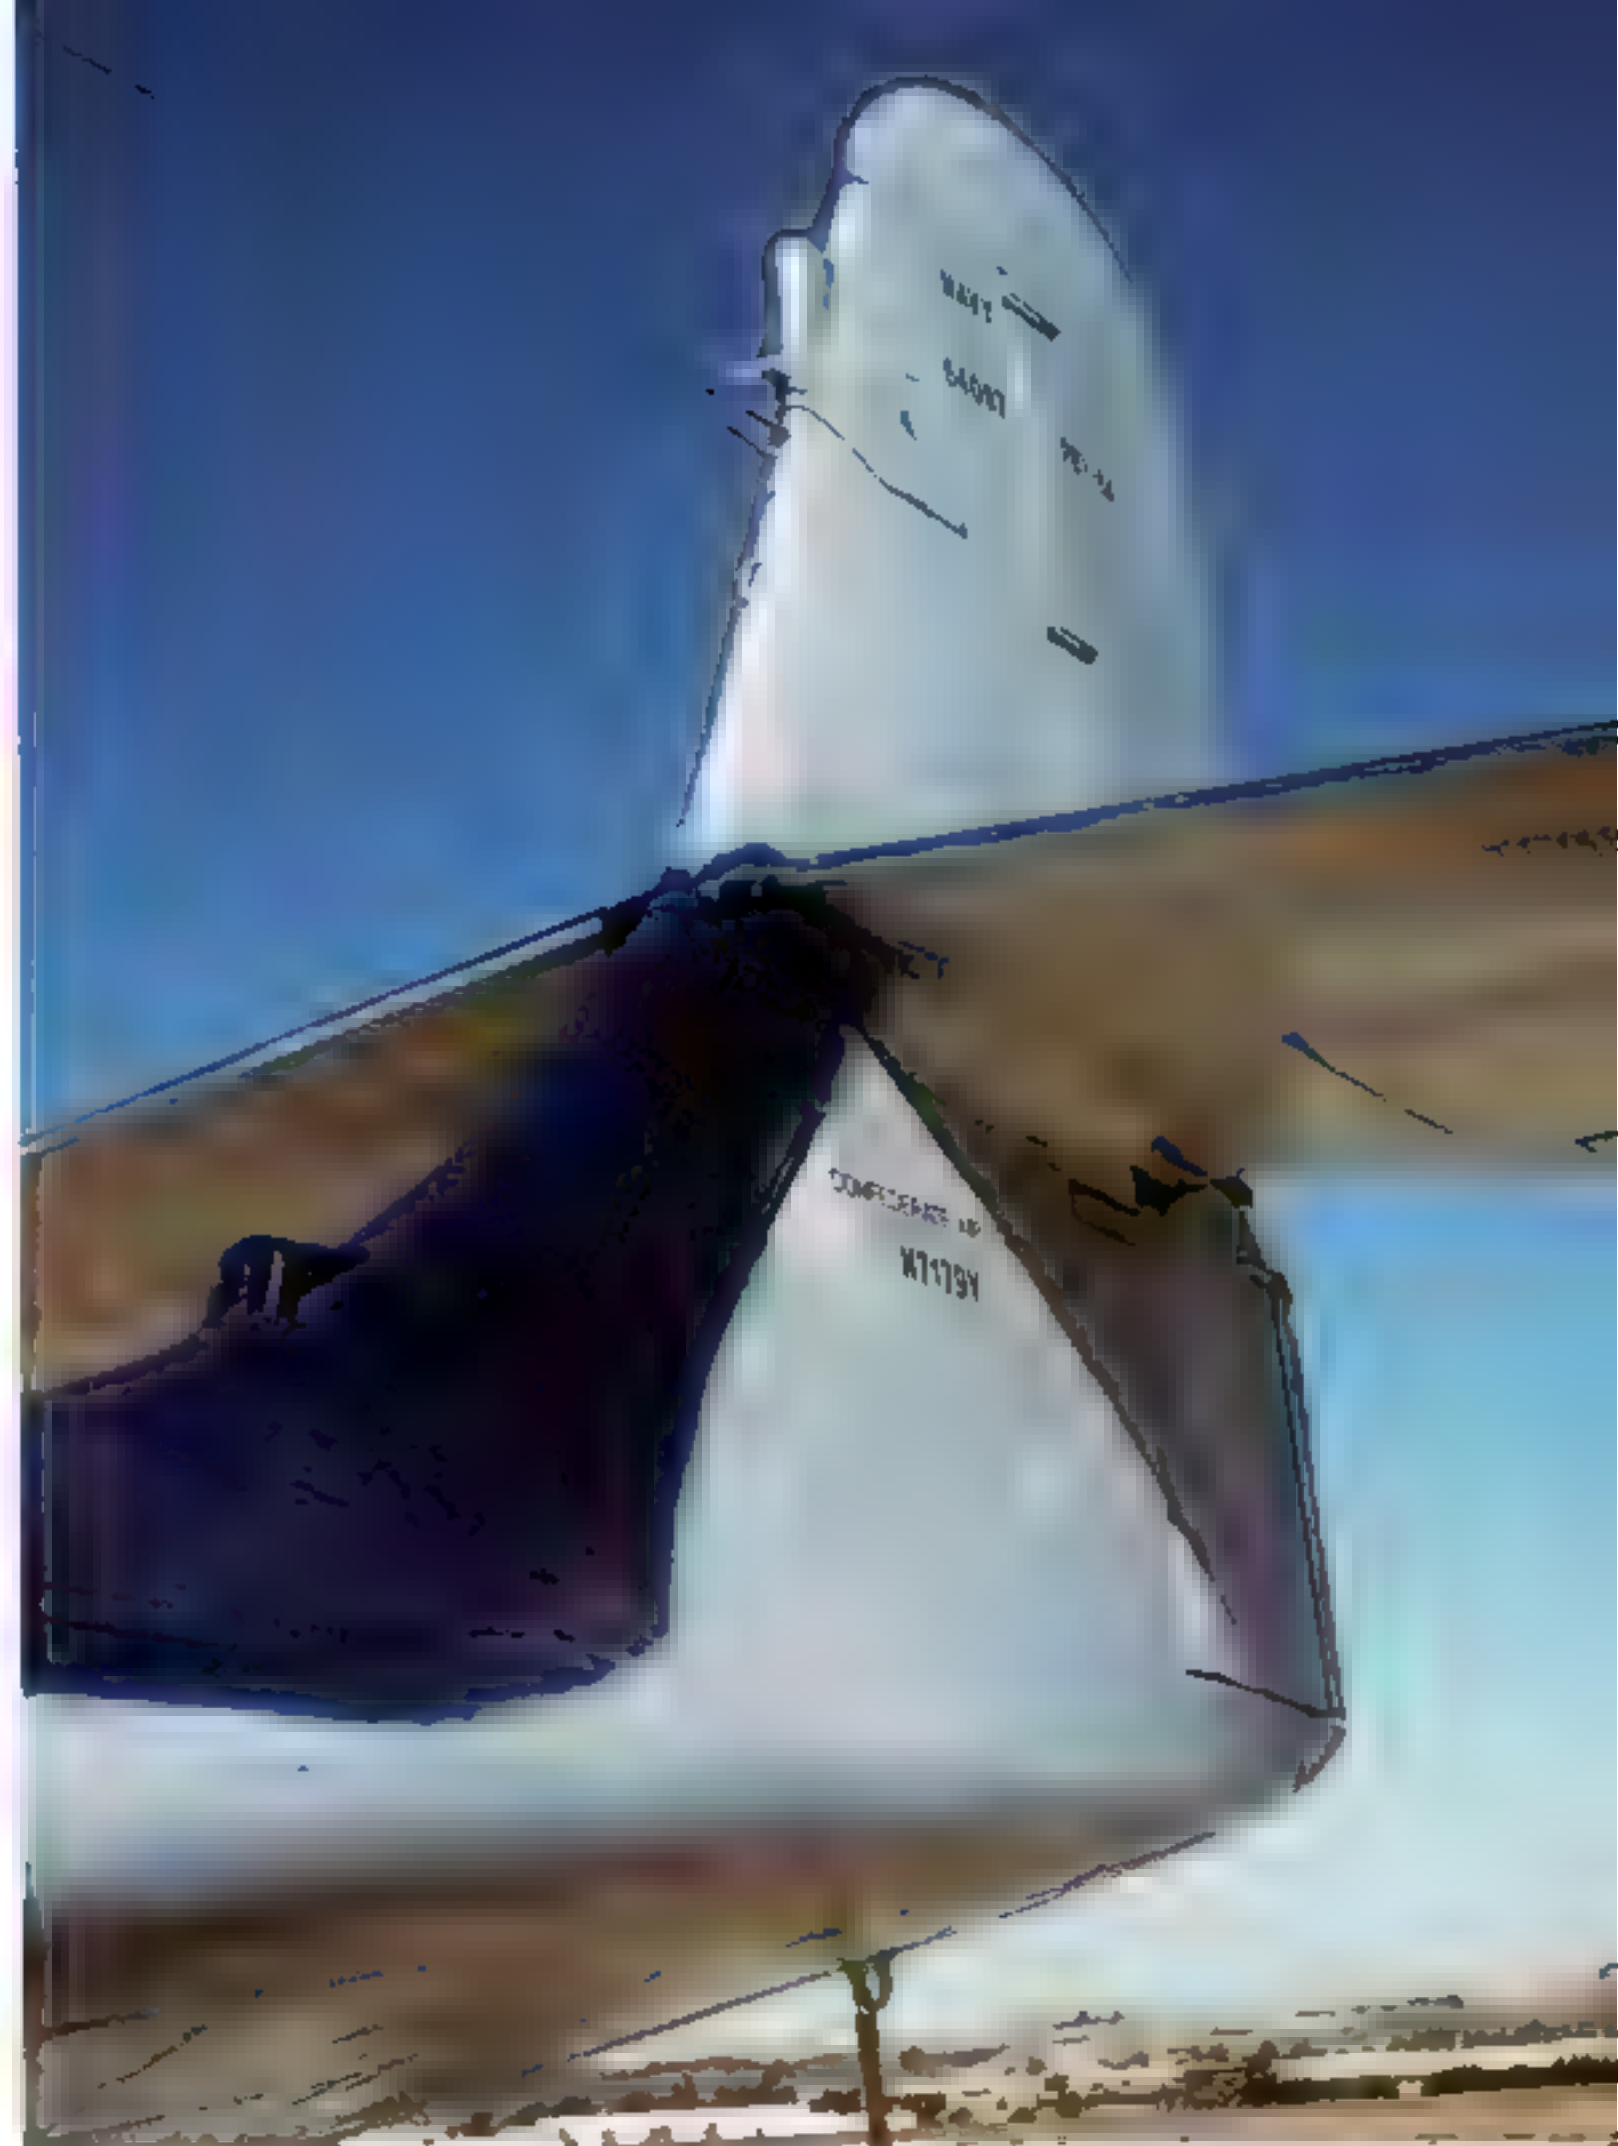
A tie-down rope is attached to the rear fuselage tie-down eye under the fin and rudder of this PBY-6A. Tie-down eyes were located under the nose, tail, leading edge of the outer wing panels and on each of the wing tip floats. (Mark Aldrich)

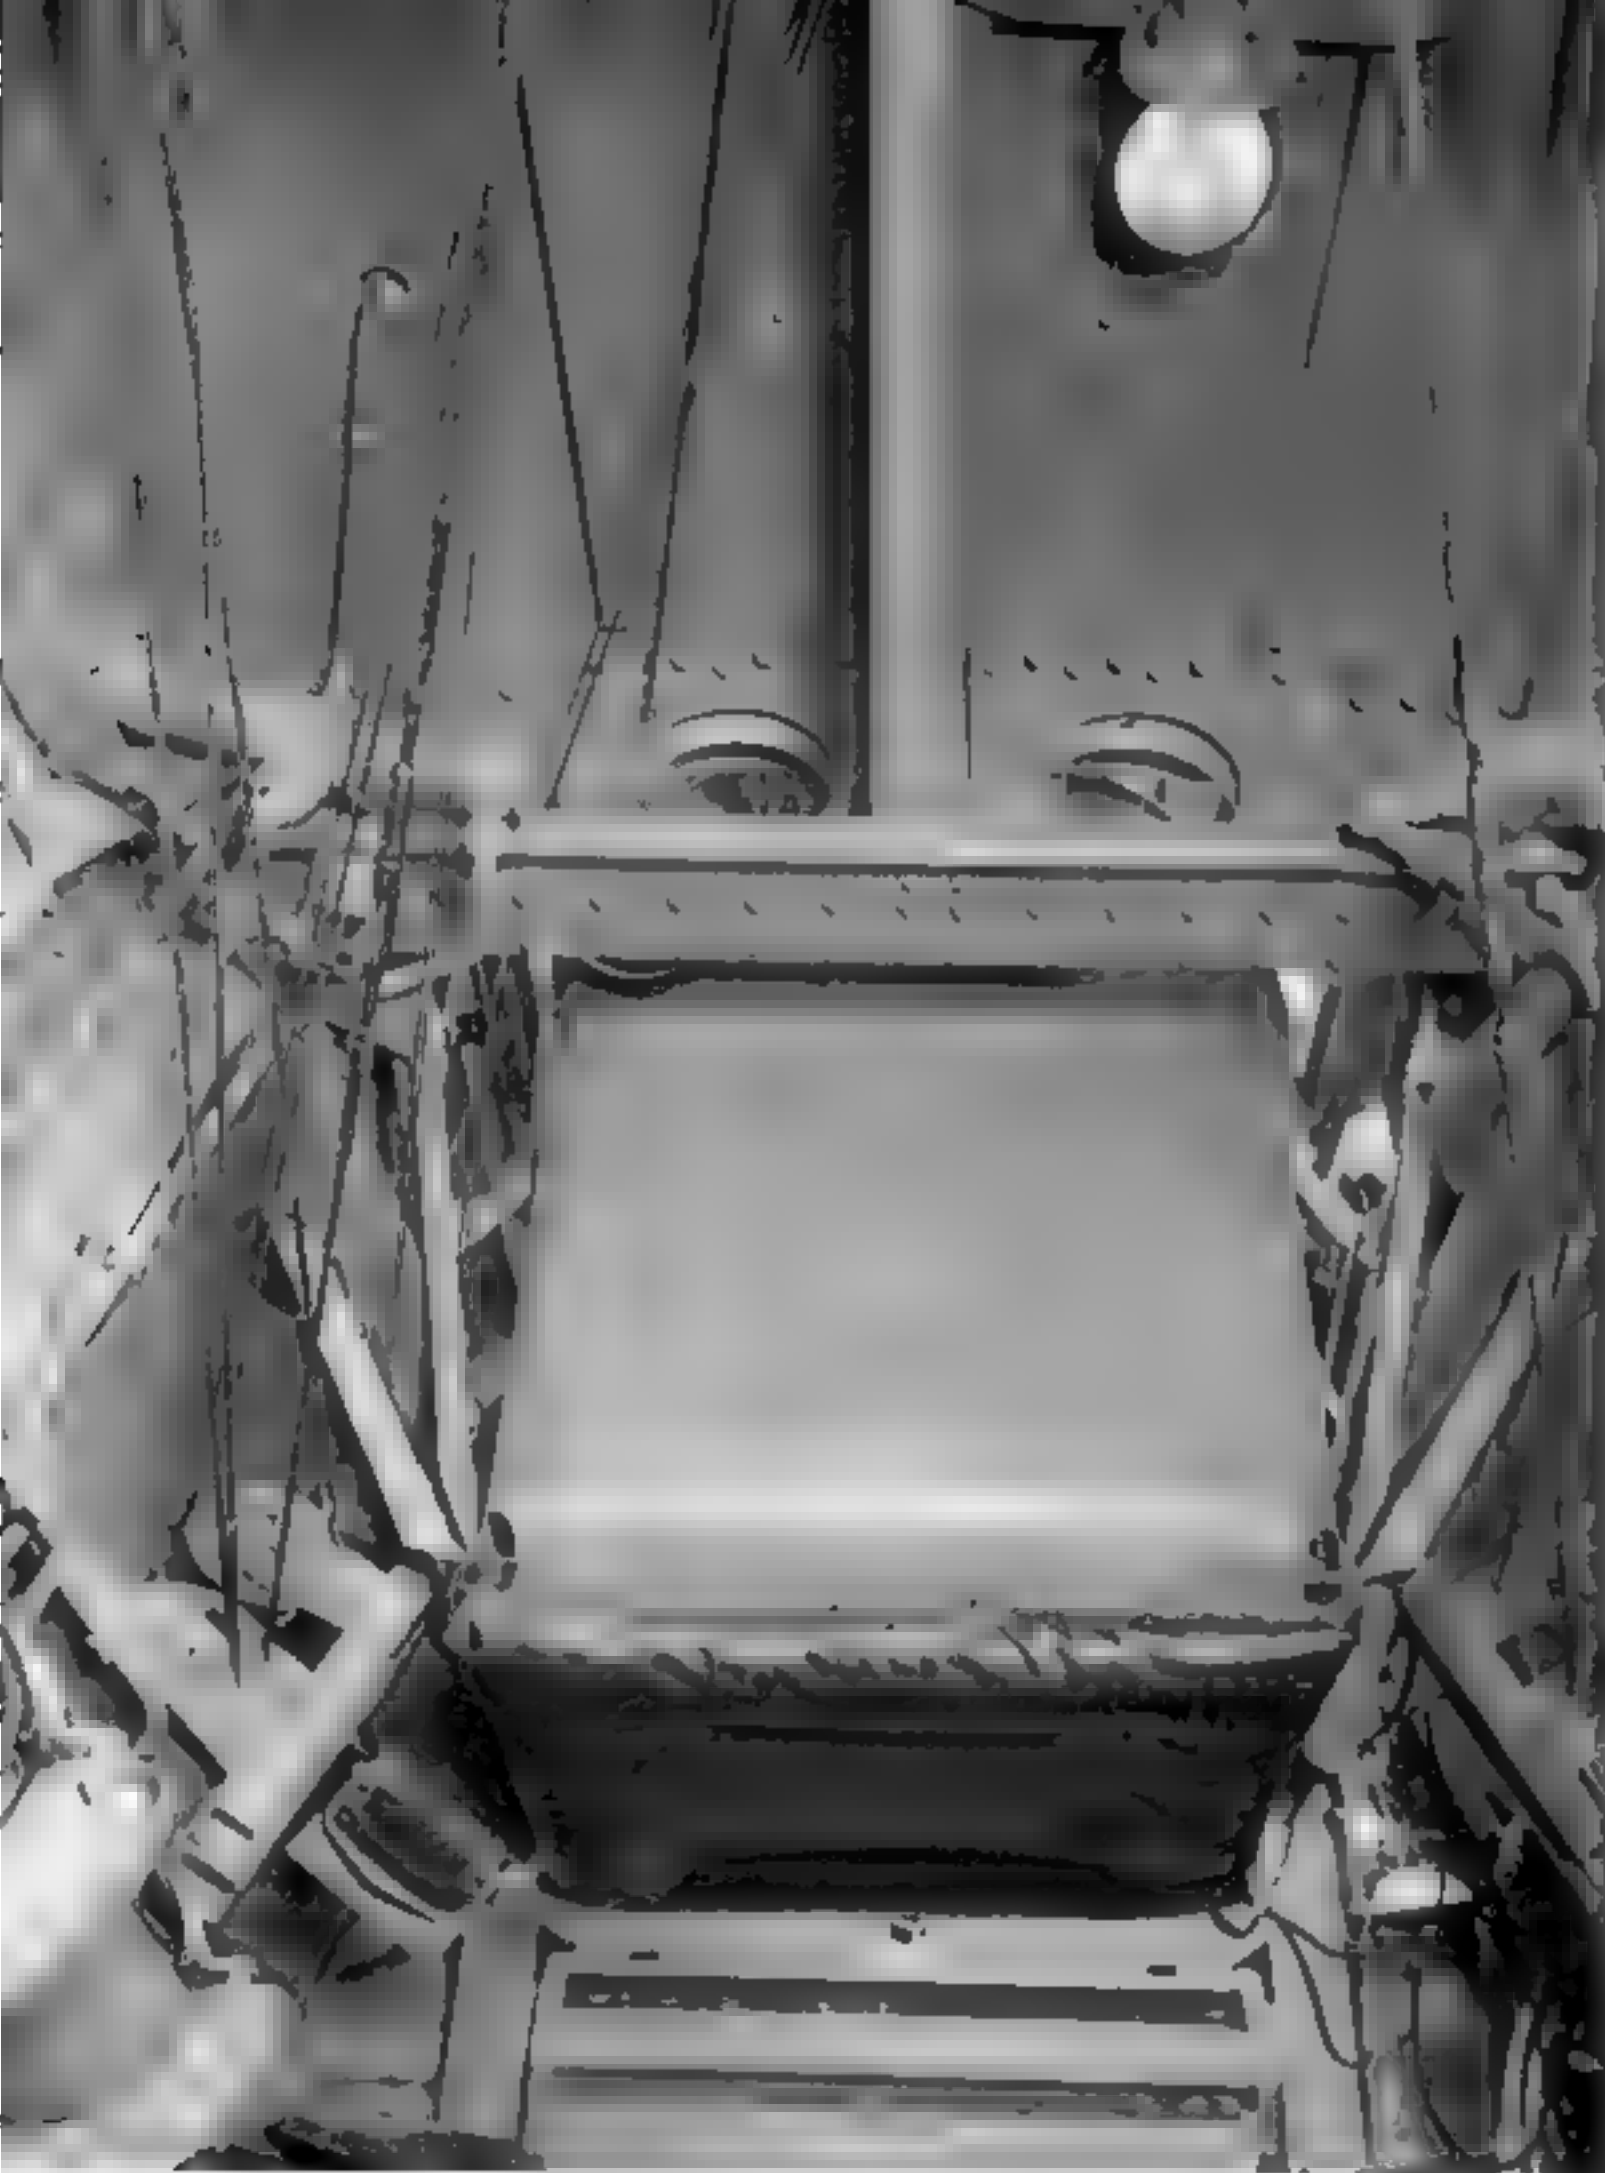
The Mechanic's compartment looking forward and up. At the lower left was the APU fuel tank. Control cables to the tailare on each side of the Mechanic's seat. The cushion was for the protection of crew members walking under the seat. (USN)

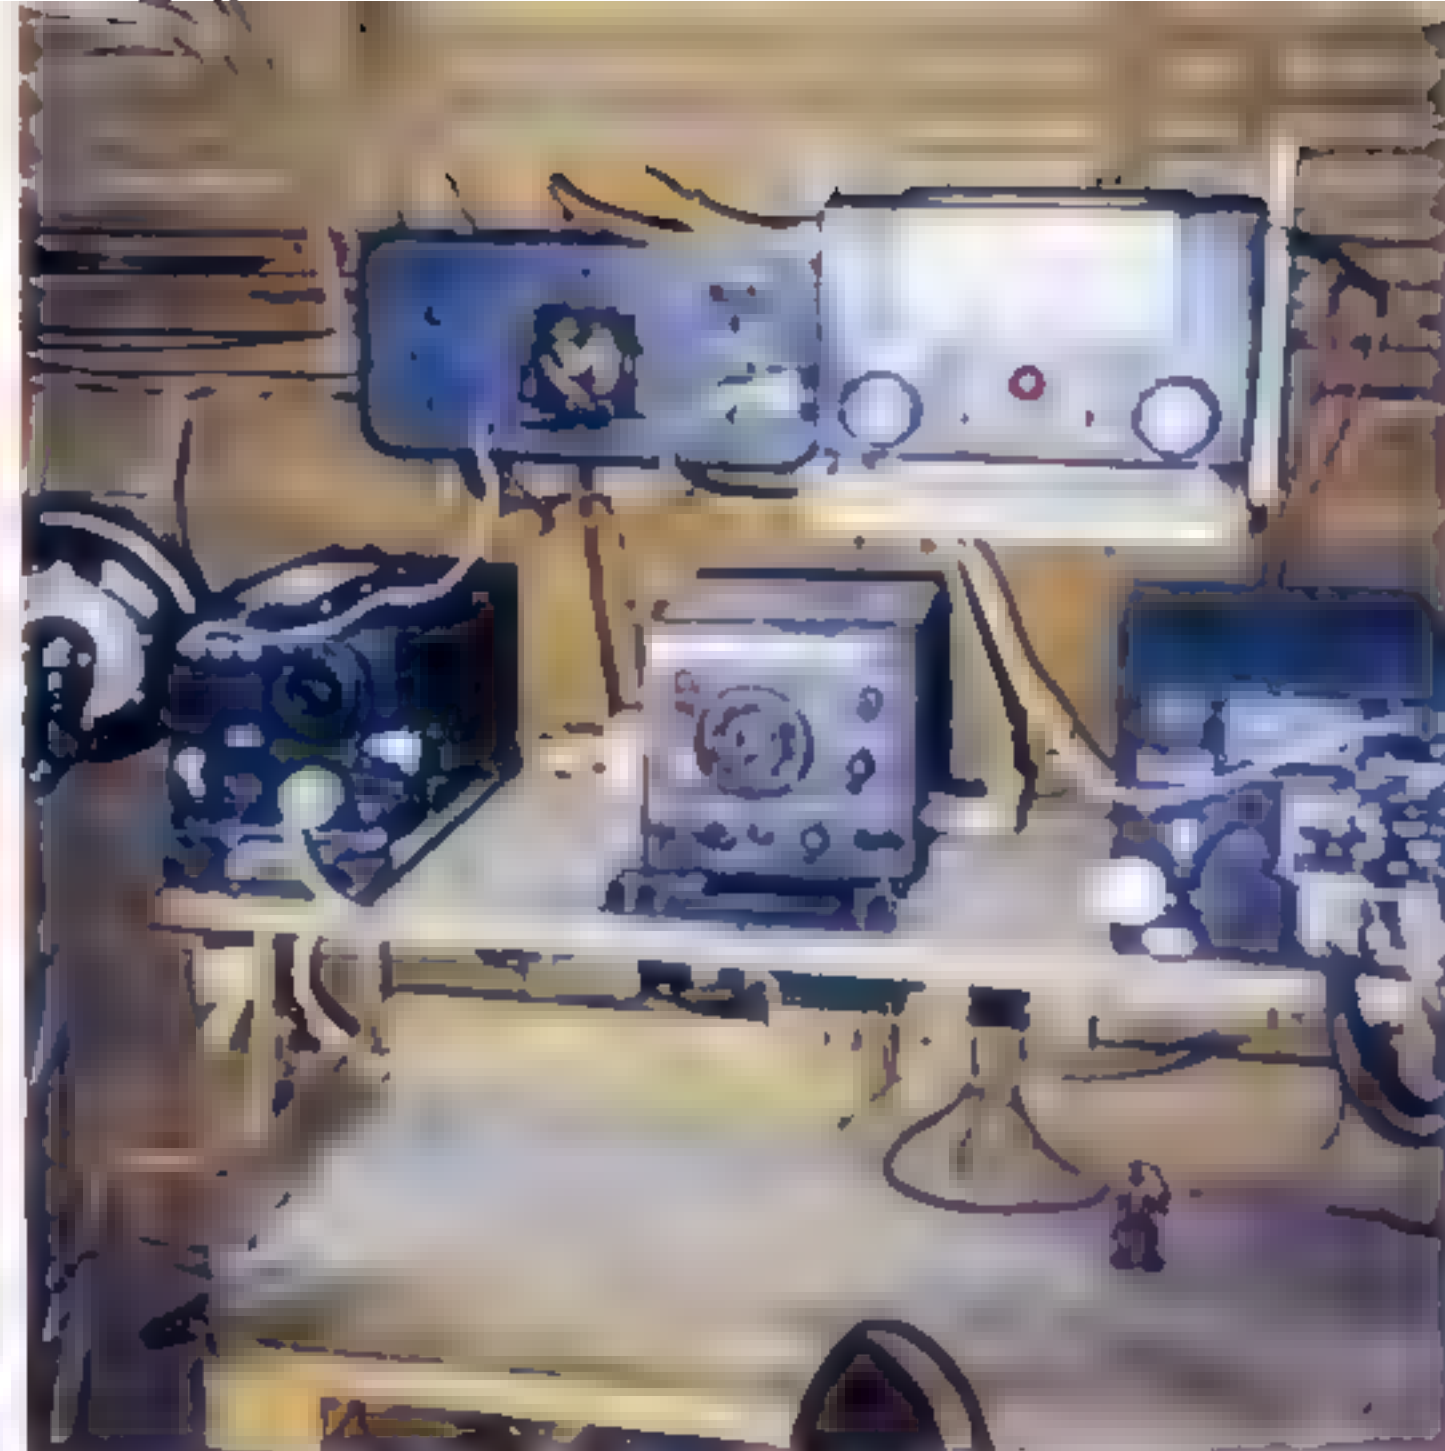
The reel with the handle is the trailing antenna. On the shelf above the desk is a RU-19 radio receiver, LM-10 frequency meter and Radio Operator's ARB unit. Above these are an antenna transfer and clock panel and ICS control. The radio operators sending key is on the desk. (Jim Mooney)

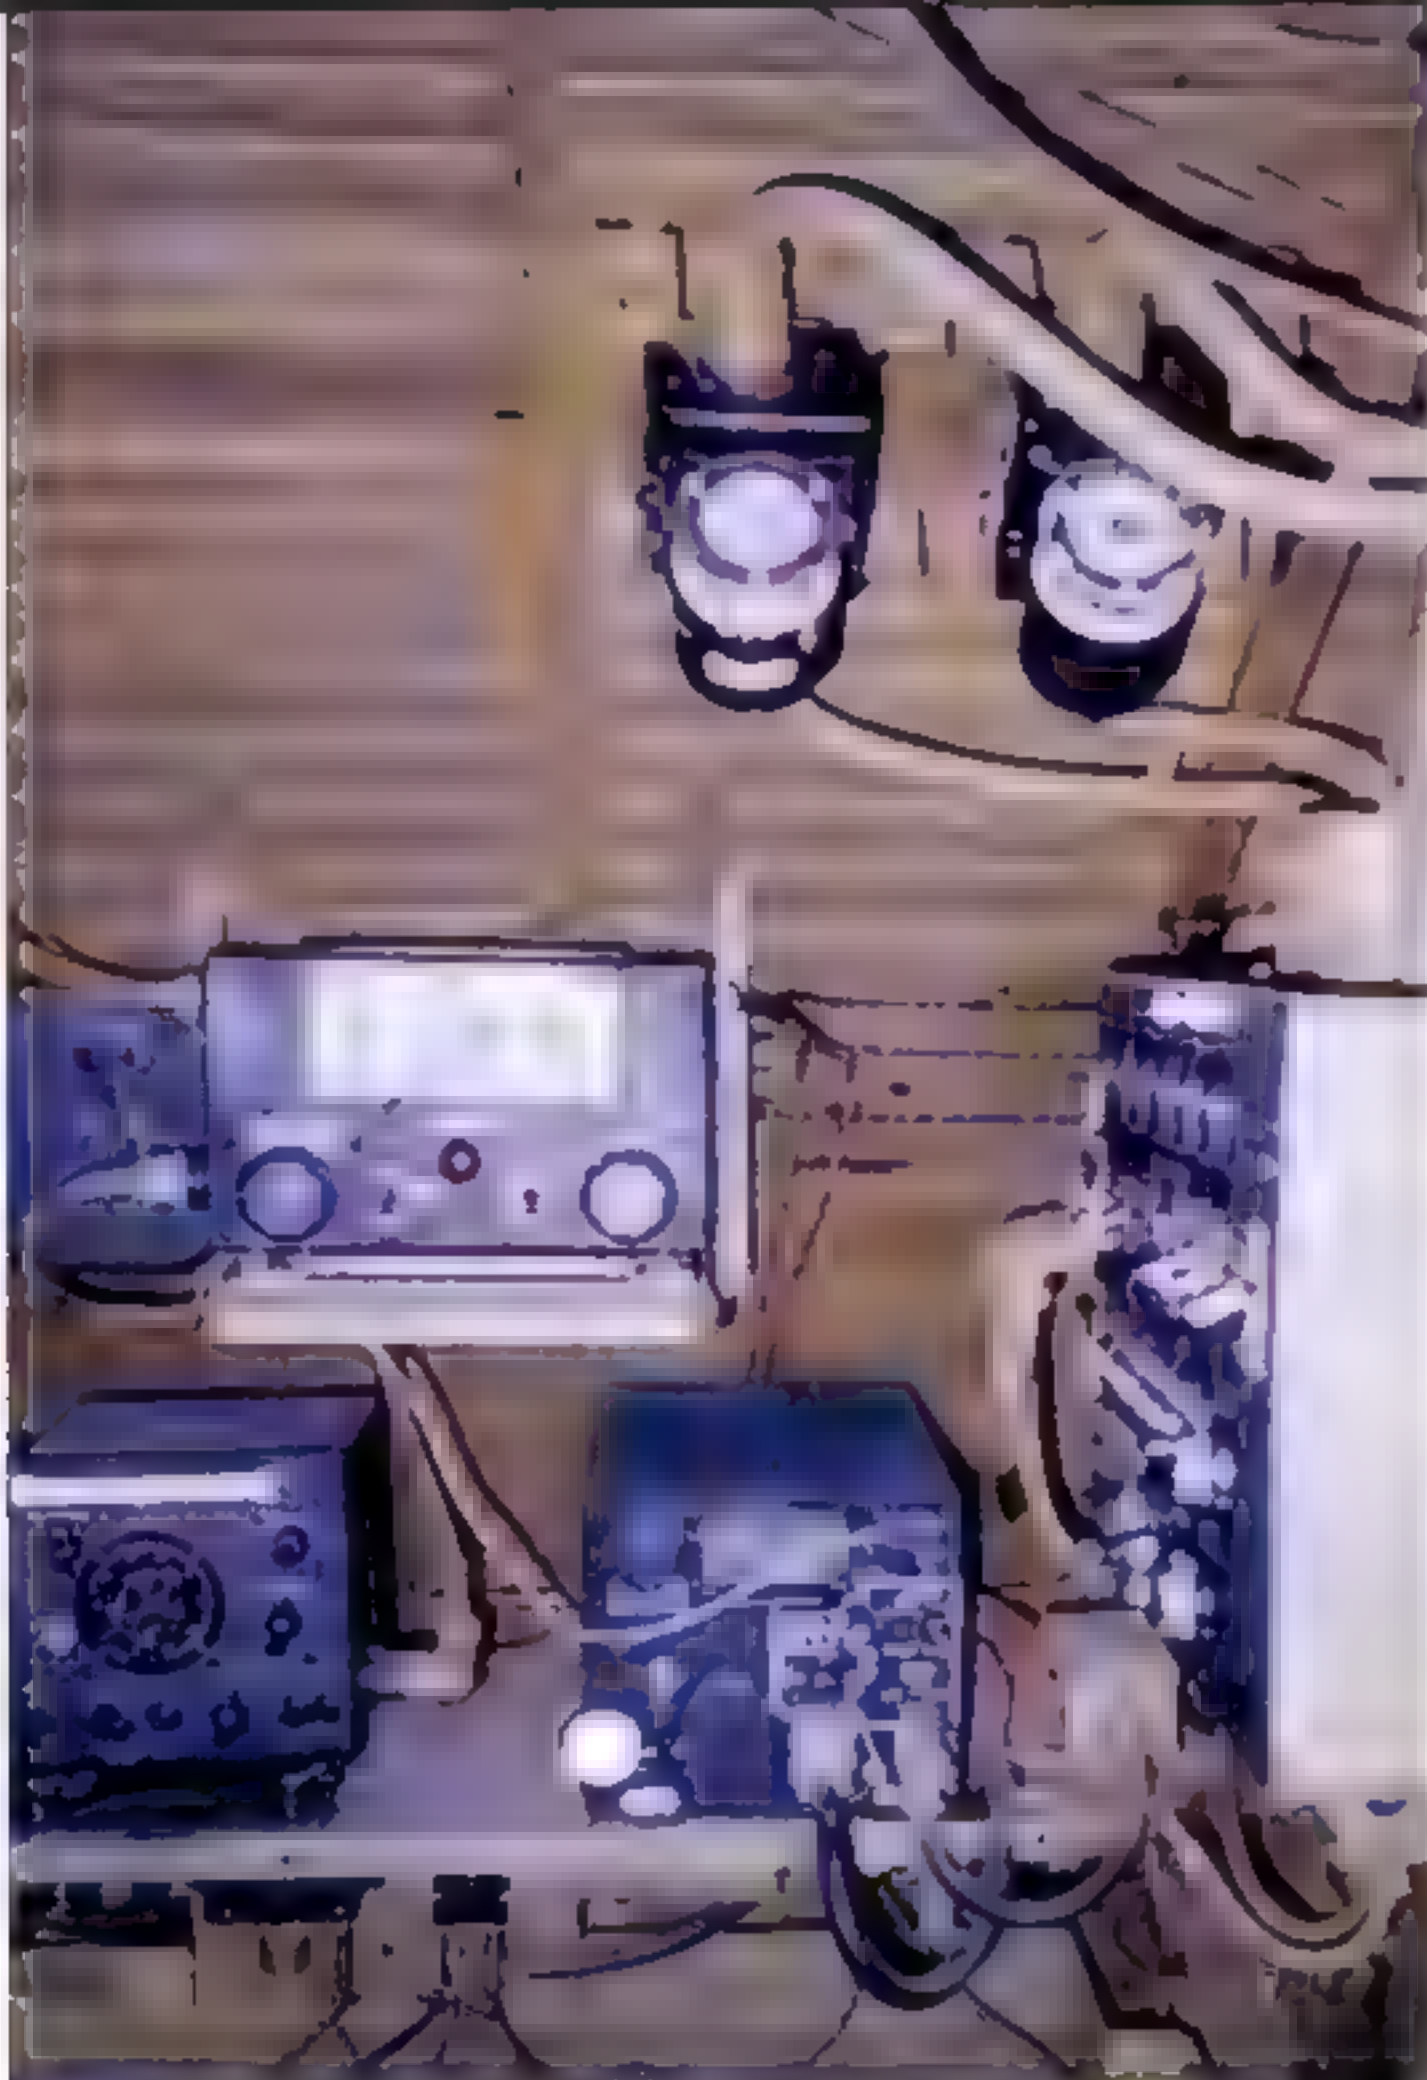
The right rear of the Navigation/Radio compartment of the PBY-5 at the National Museum of Naval Aviation at Pensacola. From forward end, on shelf above radio operator's desk, LM-10 frequency meter and ARB receiver. On a shelf above the LM-10 and ARB is the ISC control. On bulkhead, main power distribution panel. At top two engine generator voltage regulators. (Jim Mooney)

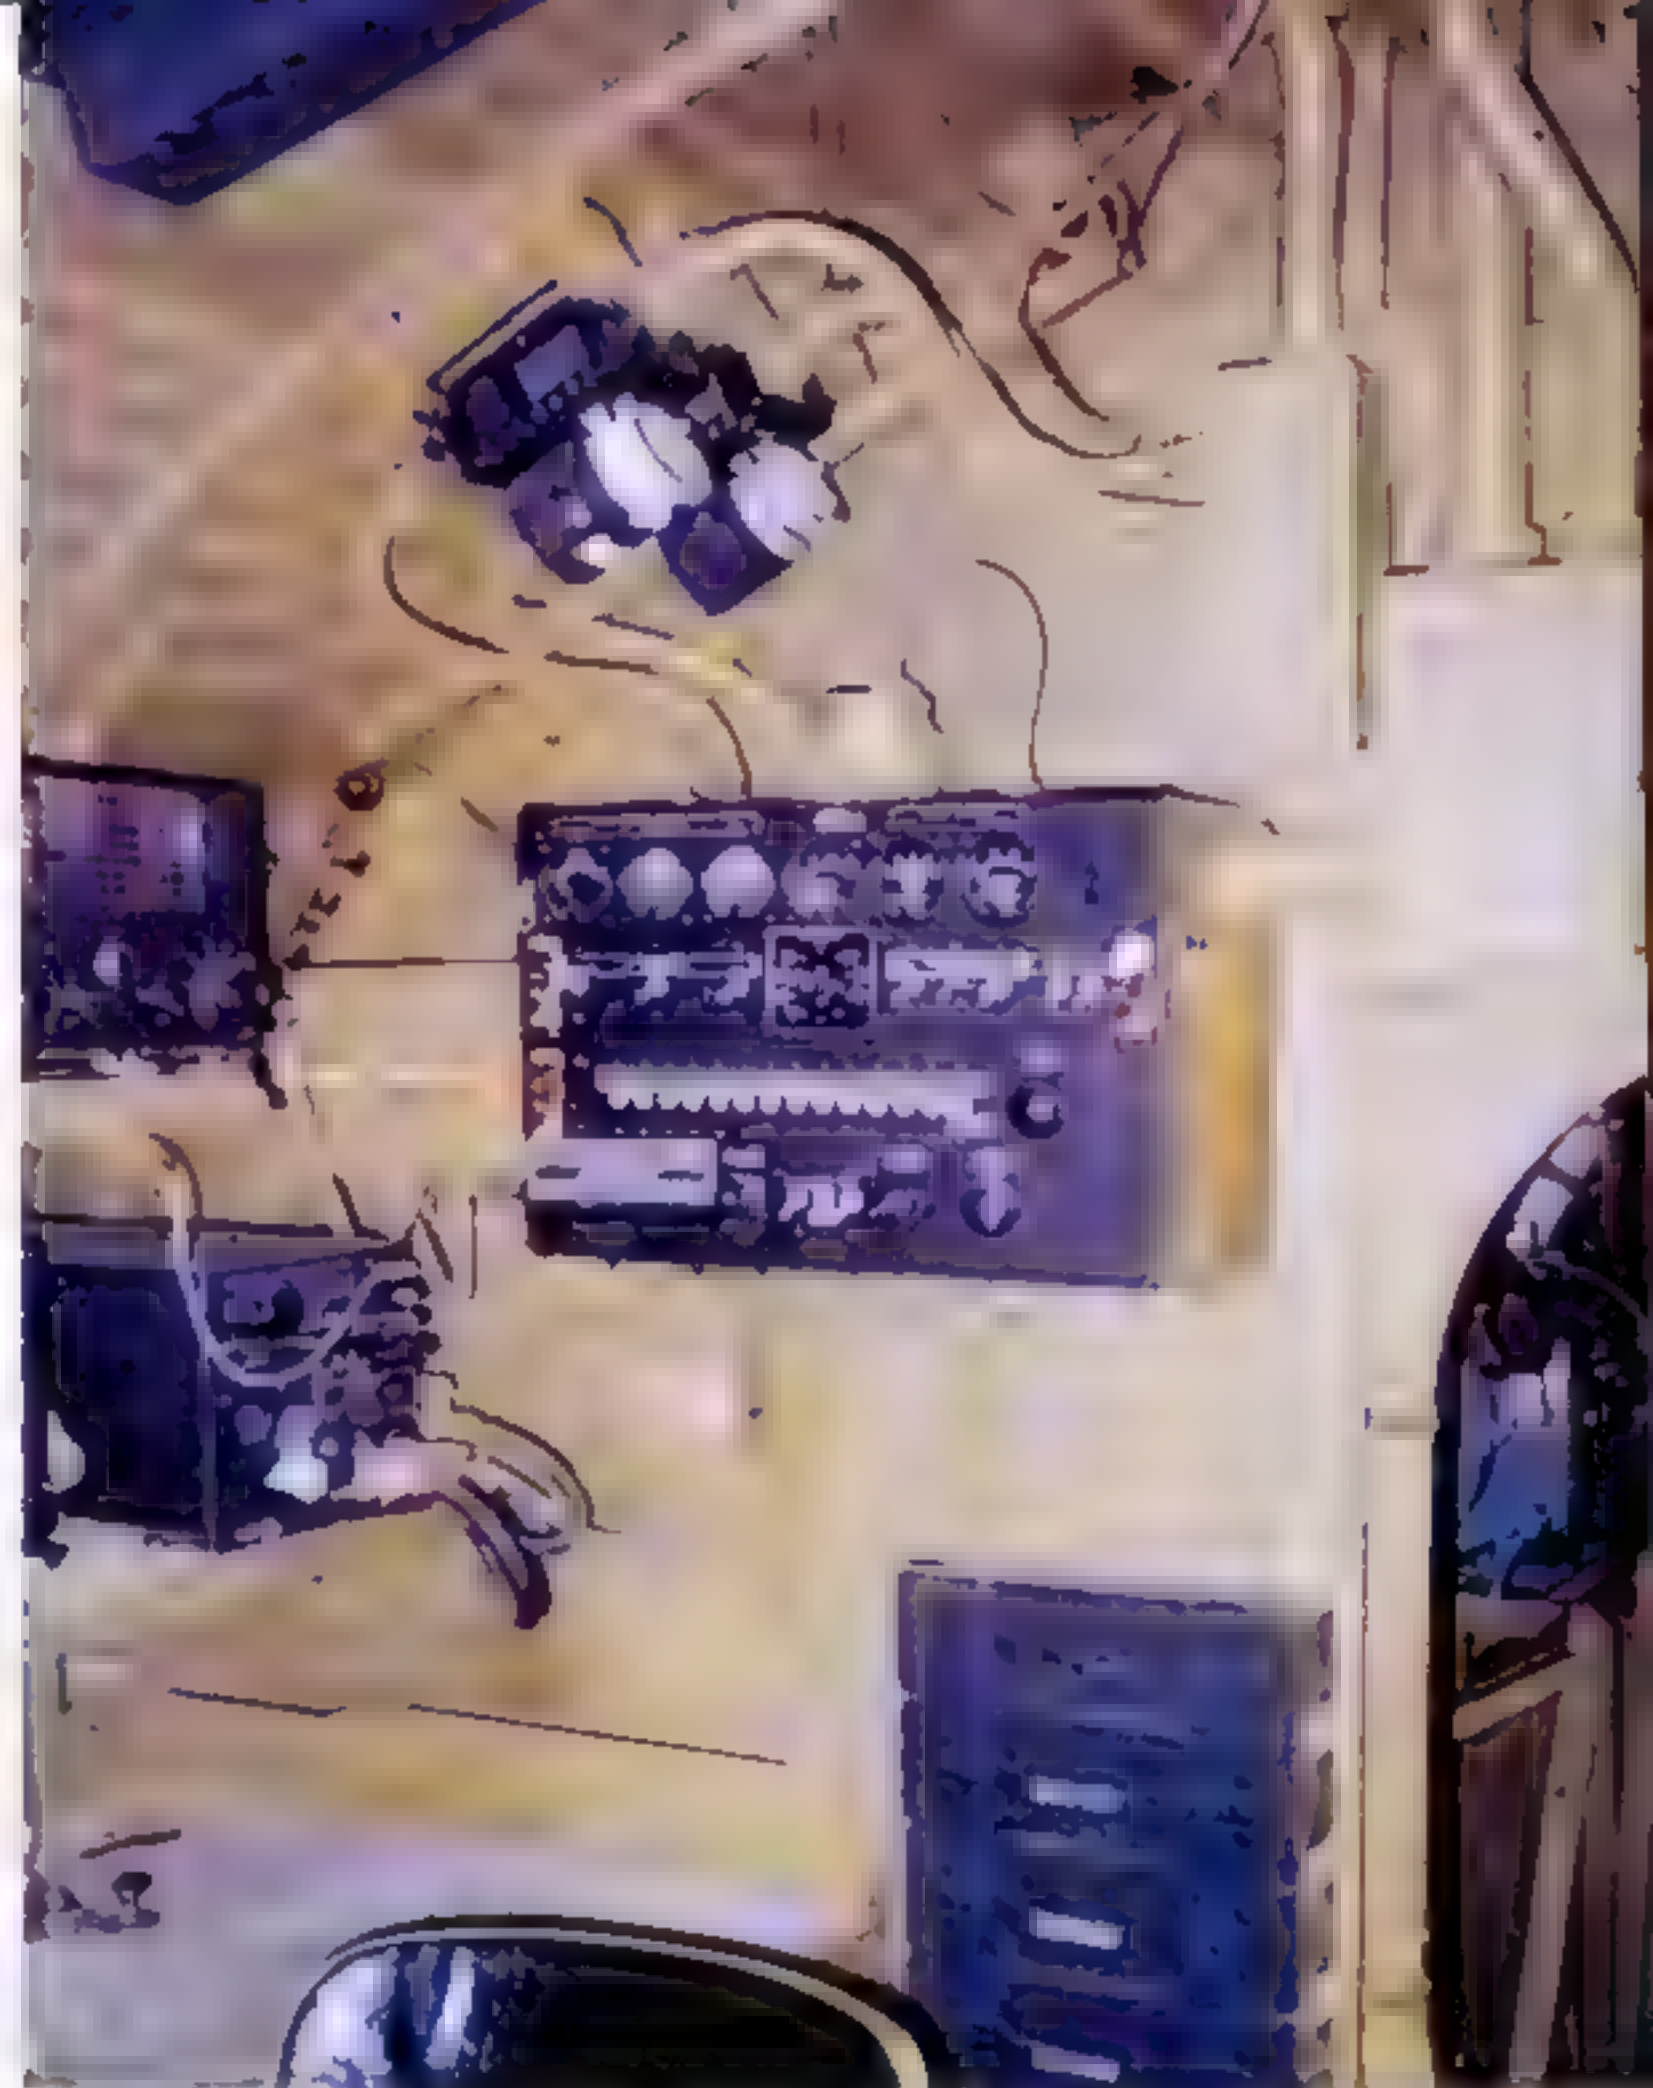
The rear bulkhead of the Navigator/Radio compartment. From lower left: Radioman's chair, Radio Key on desk, ARB Receiver, Antenna Transfer and Clock Panel, Engine Generator Voltage Regulators. On the aft bulkhead, Main Power Distribution Panel, below it are two coils for changing frequencies. The door is to the flight engineer's compartment. (Jim Mooney)
